A Proposed Repair Plan for the Pelican Boardwalk

Alaska Department of Transportation
and Public Facilities
Southeast Region Design and Engineering
PO Box 112506
6860 Glacier Highway
Juneau, AK 99801-2506

OCTOBER 2006

BOWEN ENGINEERING
4511 Chelsea Ct
Juneau, AK 99801-7309

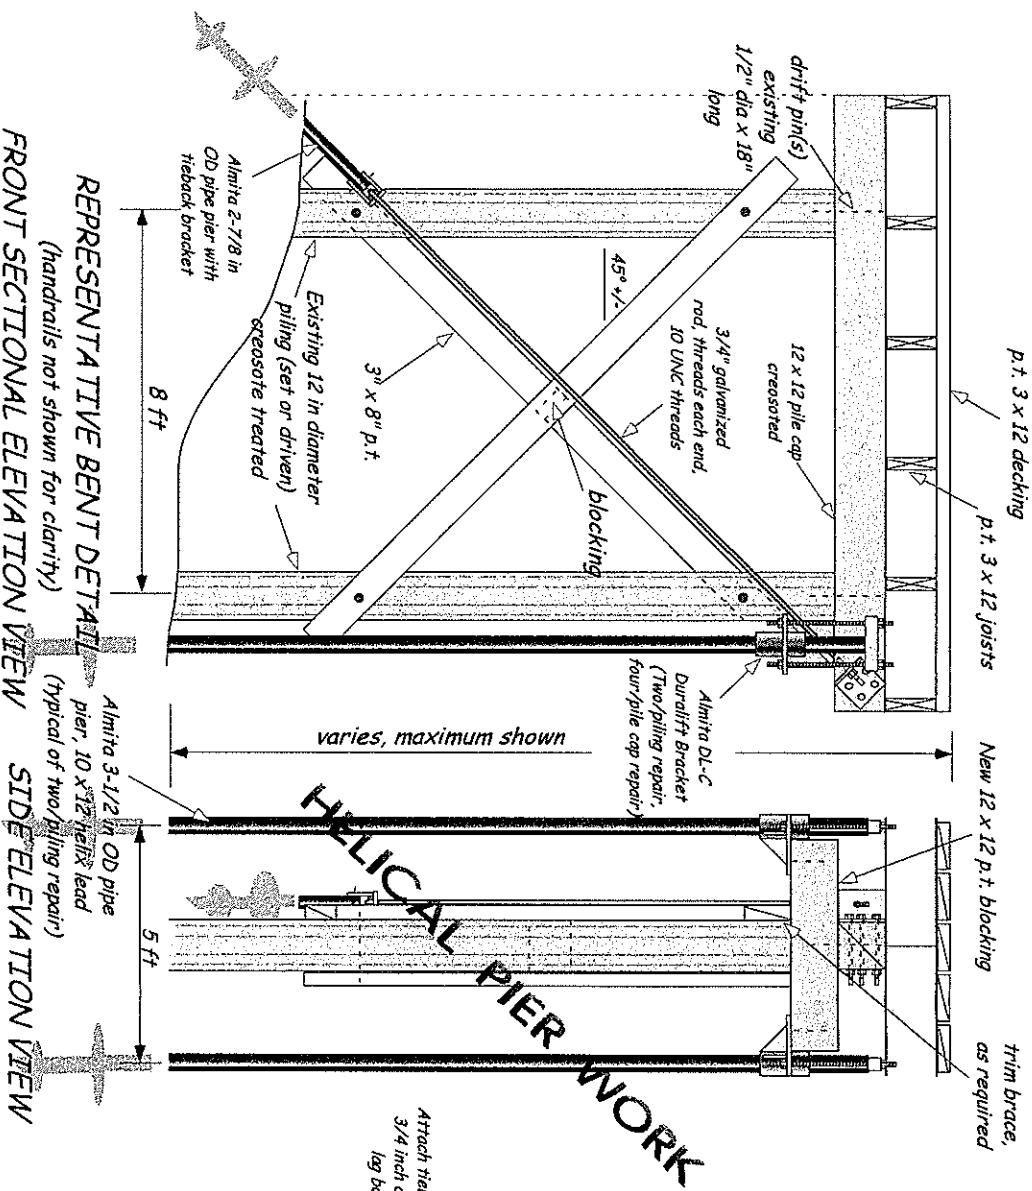
- (1) Visible portion of tieback pier to fall within foot print of boardwalk. Adjust the rod angle accordingly.
- (2) Tieback bracket per Almita Drawing No. 05-019, dated 6/24/2005.
- (3) If the tieback pier cannot penetrate the ground due to rock, use Titan 30/16 injected boring rod. Minimum bored length into rock is 3 feet. Use Titan 30/16 rod, metallized with nut. Form tieback bracket by welding loop to nut similar to Almita detail. (Detail not shown)
- (4) If helical pier tieback reaches refusal (spin out) within 5 feet of ground surface measured on the slant, retrieve helical pier and install IBO rod. Otherwise 4000 ft-lbs torque minimum on helical pier.
- (5) Tieback placement is inter-tidal work.

New 12 x 12 p.t. blocking
as required

trim brace,
